# **Nomination for Inclusion on the List of Buildings Of Local Interest**

**Bolton House  
10 Bolton Road  
BN21 3JY**

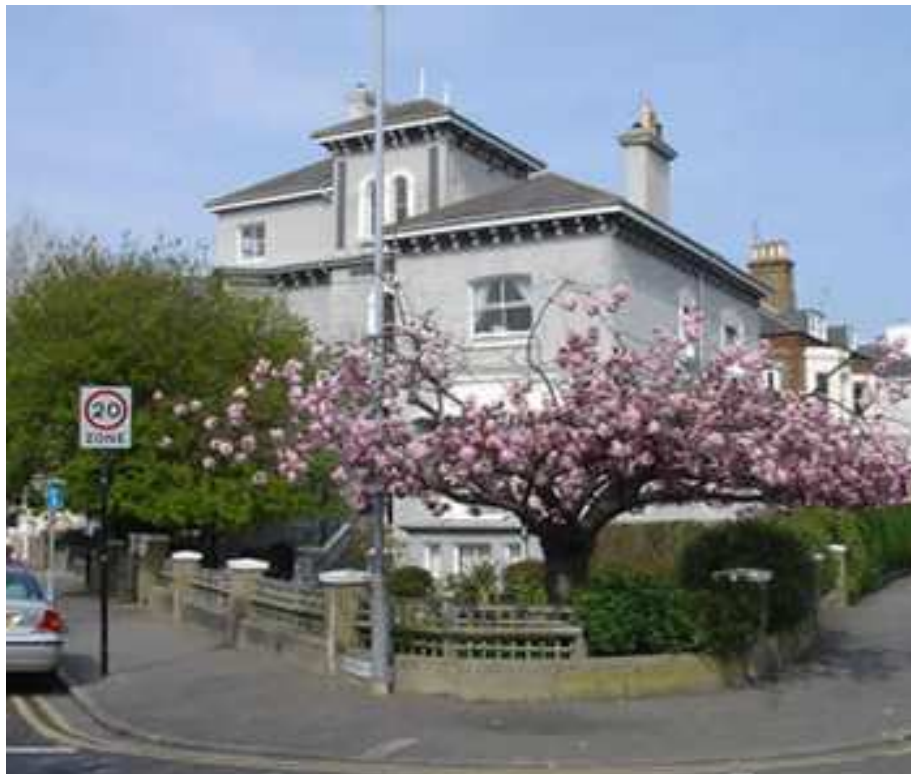
- Italianate style
- Substantial detached form
- Set back from road with front areas and a small side garden
- Four, rising to five storeys, with unusual glazed Italianate glazed lantern

- Lantern and structure beneath has fenestration to emphasise the verticality of this section of the building, has a double corbelled detail to generous eaves. Two zinc finials complete the structure

- Shallow pitched slate roofs, with bay windows, some of which are slate, with generous corbelled eaves
- Highly distinctive zinc hoods to bay windows, these are cut and pierced to unique design

- Windows are vertical sliding sash with pronounced and moulded reveals and keystones with bracketed stone cills. Windows to upper Ground floor mostly 4 over 4 with slender pilasters between bays. Upper floors are plain (rear and upper floor), or without decorated reveals, but having decorative label mould

- Slim chamfered quoins to returns
- Many windows contain original glass and original window furniture
- Chimney stacks, with little decoration - 80% original pale ceramic pots

- Painted stucco finish, which has deteriorated in places. This is currently painted grey with white highlights to doors, windows and quoins. This would originally have been white.

- Boundary wall, 400mm approx, with gate piers, rendered with chamfered stone cappings

- Iron railings, with fleur du lis finials exist to some sections, notably on Lismore Road
