Agenda Item No: 7 **Report No:** 28/15
Report Title: Western Road Lewes Public Toilets Petition Response
Report To: Council **Date:** 25th February 2015
Cabinet Member: Cllr Andy Smith
Ward(s) Affected:
Report By: Gillian Marston, Director of Service Delivery
Contact Officer(s)-
Name(s): Bee Lewis
Post Title(s): Head of Property & Facilities
E-mail(s): bee.lewis@lewes.gov.uk
Tel No(s): 01273 661101

To respond to the petition submitted to Council on 15th October 2014 in relation to the public toilets at Western Road Lewes.

Appendix B: Site Photographs

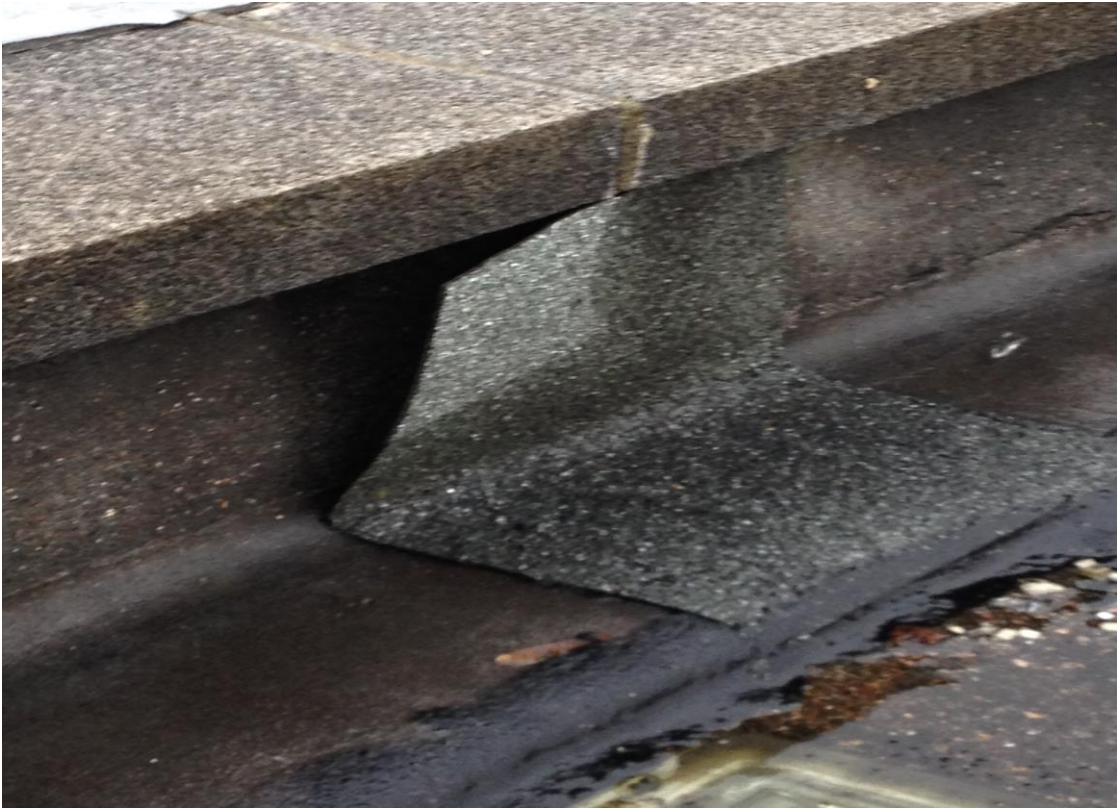
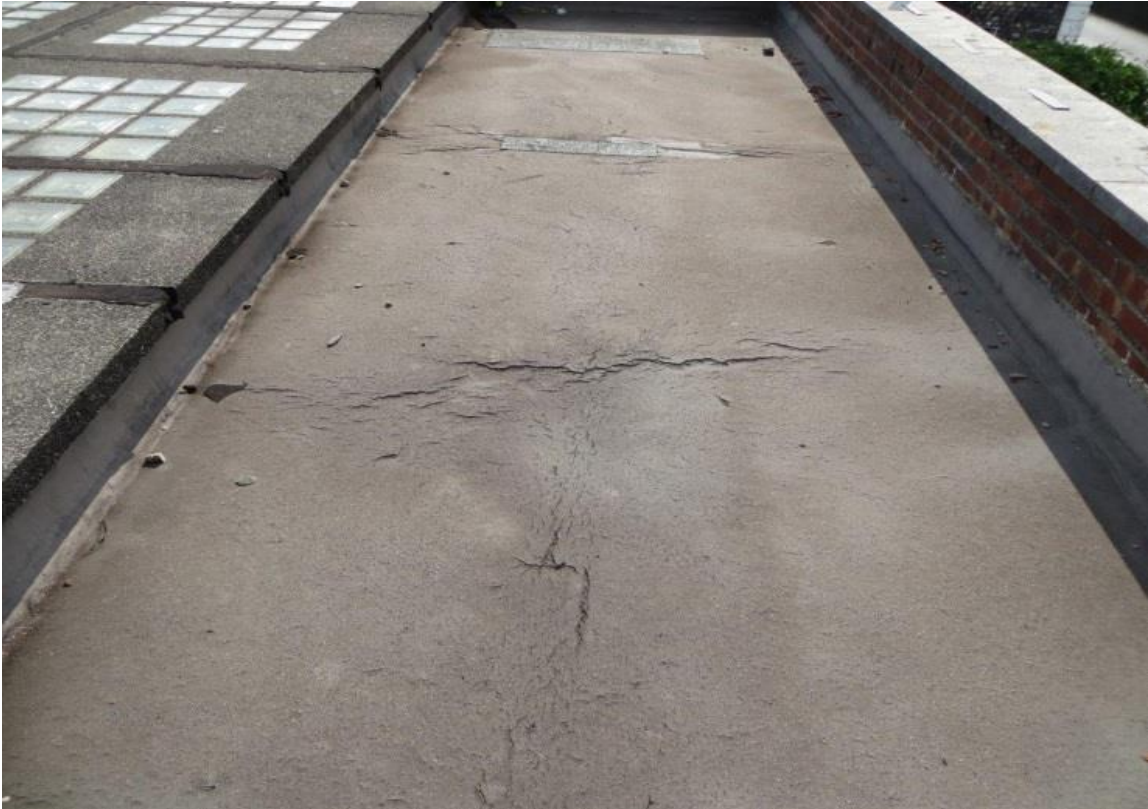
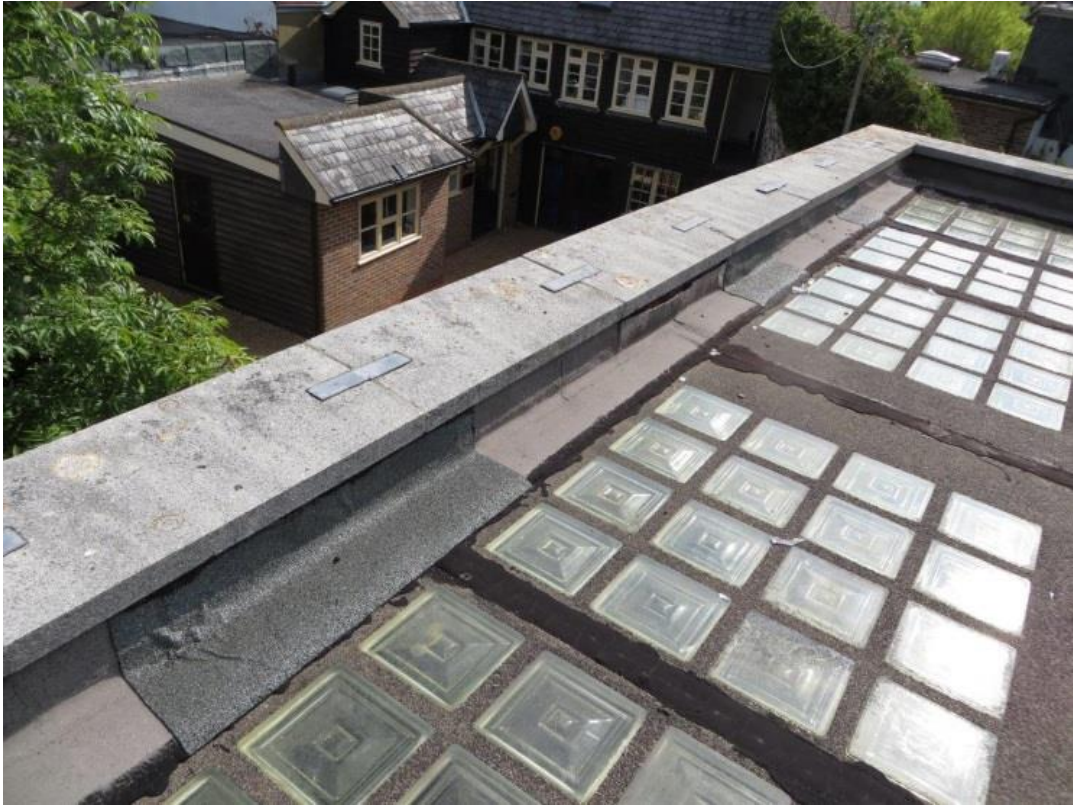
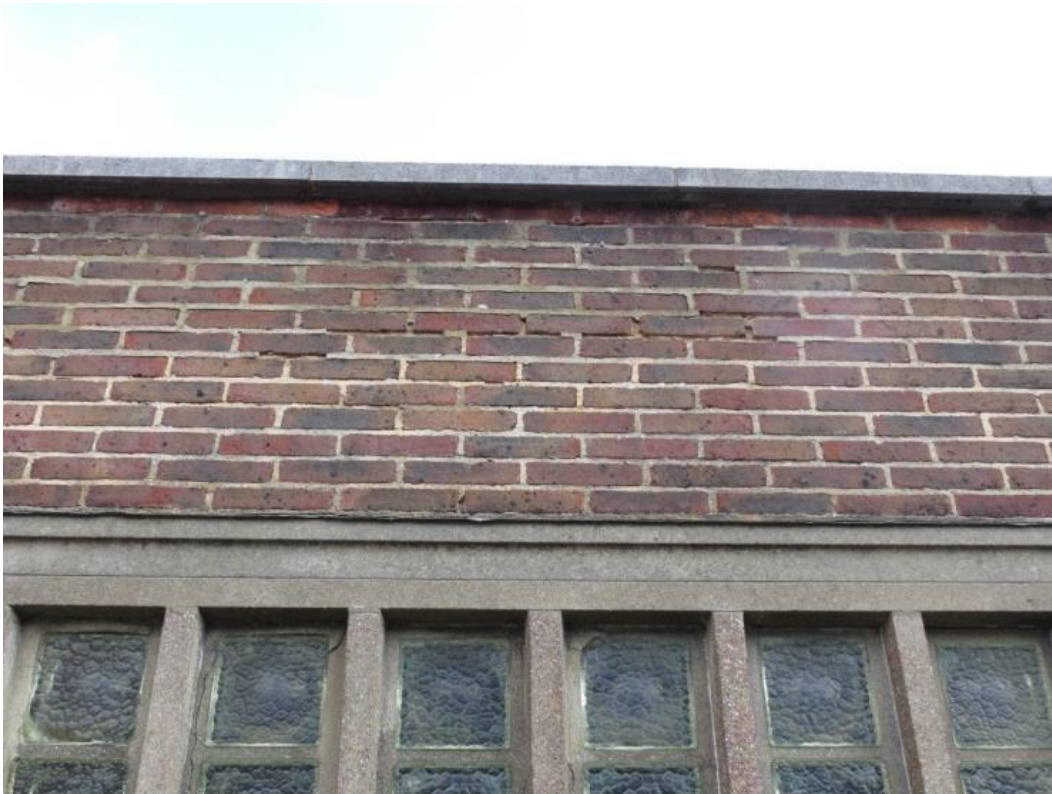
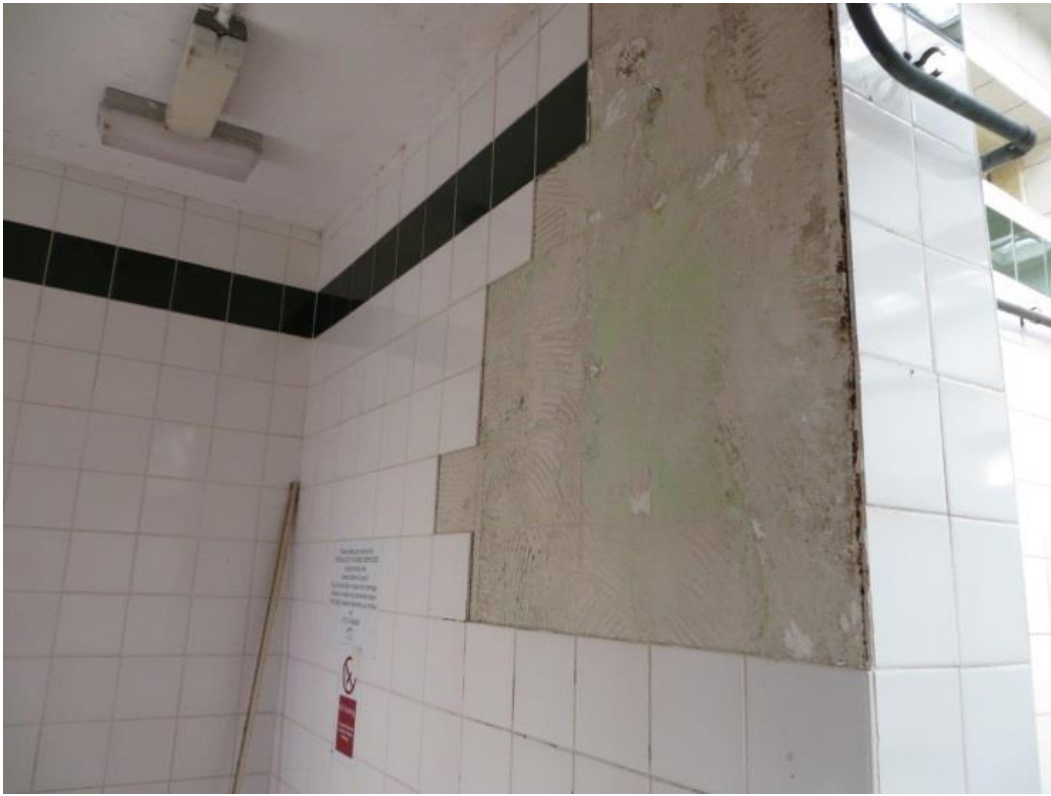
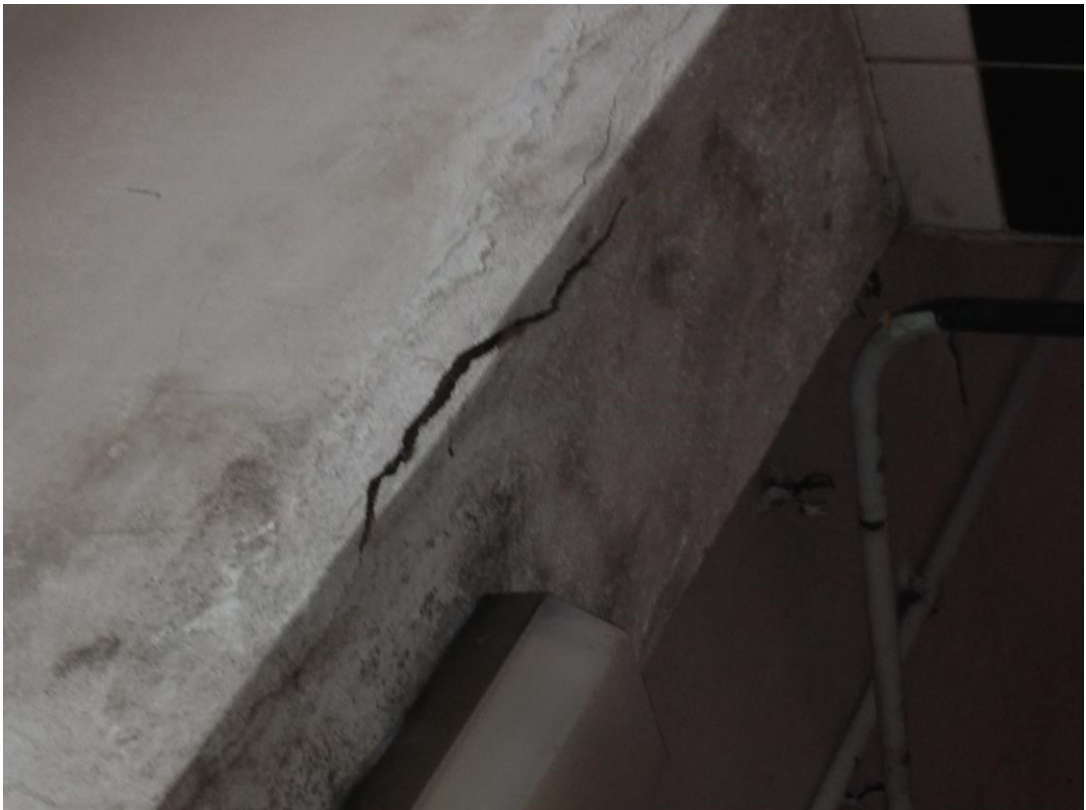
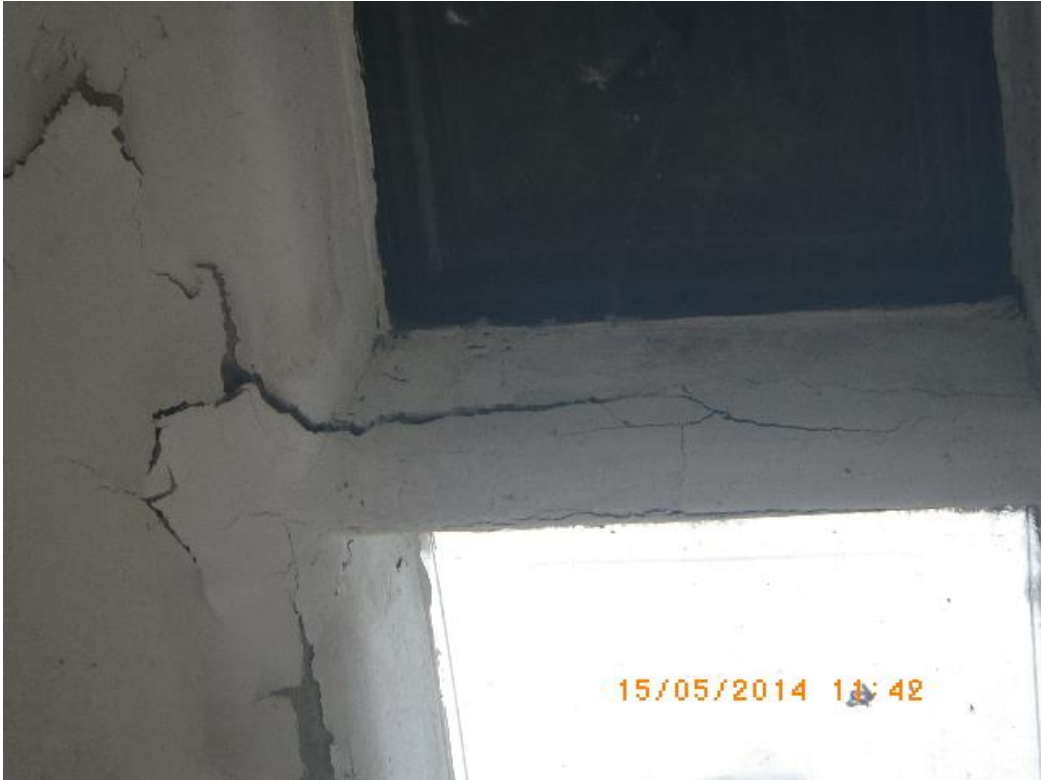
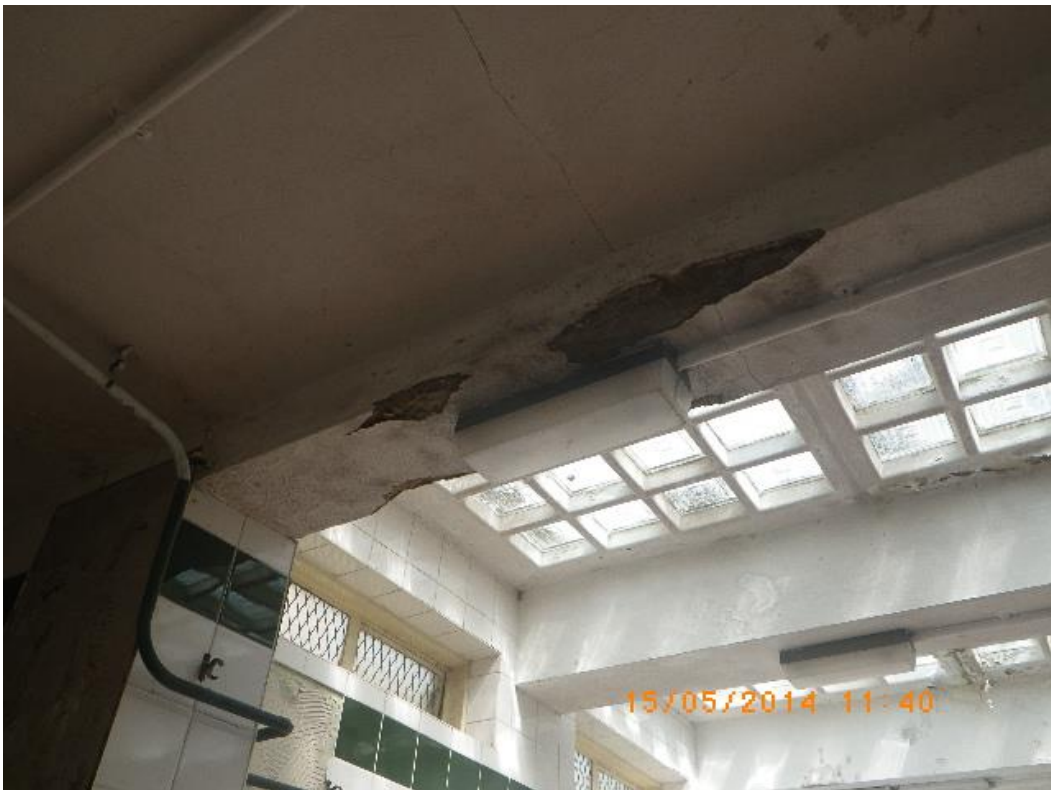
- (a)** Water ingress through junctions of pavement light units to roof.
- (b)** Lintel over rear windows failed.
- (c)** Spalling concrete around glass bricks to front elevation.
- (d)** Ceramic wall tiles lose and loss of key in isolated areas.
- (e)** Water ingress damage to electrical wiring and luminaires.
- (f)** Installations and equipment to be fully checked and commissioned before presently closed areas are re-opened.
